## Report on work done in Ömnögovi Province, Mongolia, June 8-23, 2024

As part of The Wall project, a collaboration between the Hebrew University, National University of Mongolia and Yale University, we conducted a field work in Ömnögovi Province. The work was focused on a line of wall located parallel to the Mongolia-China border and on structures of different kinds located along this line and in its vicinity (Fig. 1). The wall-line is stretching, in an arc shape, from point 42.17358, 102.41393 in the west to point 41.986, 105.87545 in the east. This wall line was already identified by Baasan (2008: 73). An extensive survey of this wall line and associated structures was carried out, between 2005 to 2012, by Erdenebaatar Diimaajav and Alexey Kovalev and by the Joint Mongolian – Japanese team (Kovalev and Erdenebaatar 2021; Moriya et al., 2014). In the east this wall line continues into China where it was extensively surveyed by Chinese archaeologists (Wei 2010; Zhang 2023).

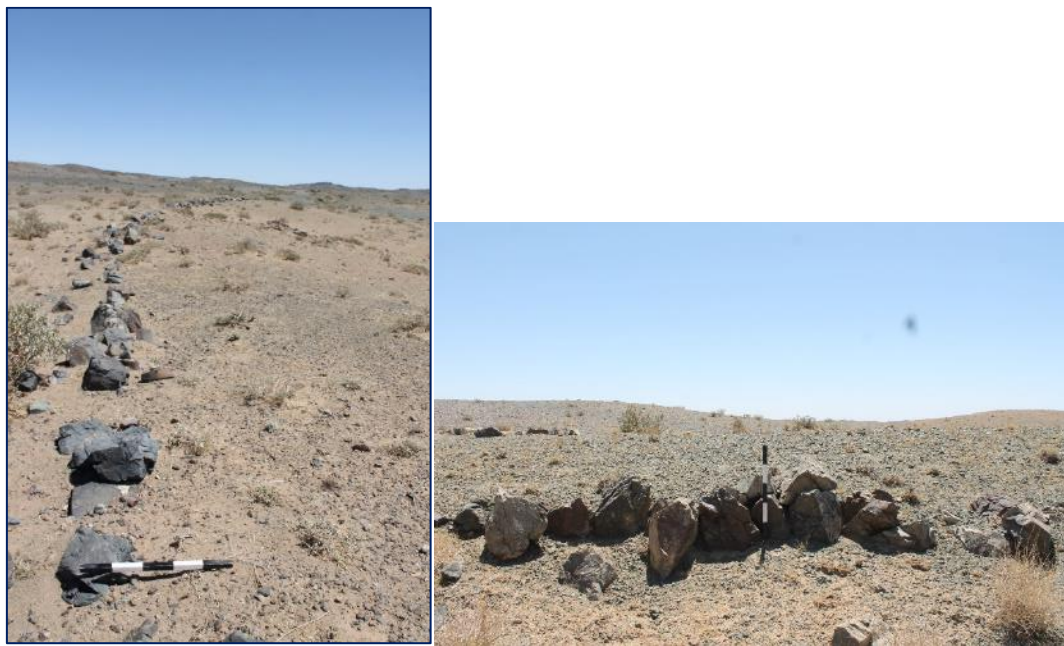
Fig. 2: The wall line north of enclosure G10.

highly eroded and covered by sand while at other locations it stands more than 1m high. An example for an eroded wall section were observed, for example, north to enclosure G10. Here a line of stones, which was slightly elevated above the surrounded ground and partly covered with sand was observed (Fig 2). At other locations larger number of stones are visible on the surface and the width of the wall is more clearly visible (Fig. 3). At different locations surface observations suggest that the wall was made of inner and outer faces, made of stones or wood with the space between them filled with earth. This observation was confirmed for the section excavated near site G05 (see below) but it is not necessarily true for all sections. The section that climbed to the top of an isolated mountain, between coordinates 42.18166, 103.03747 to 42.17551, 103.02561 is very well preserved and is made entirely out of stones (Fig. 4).

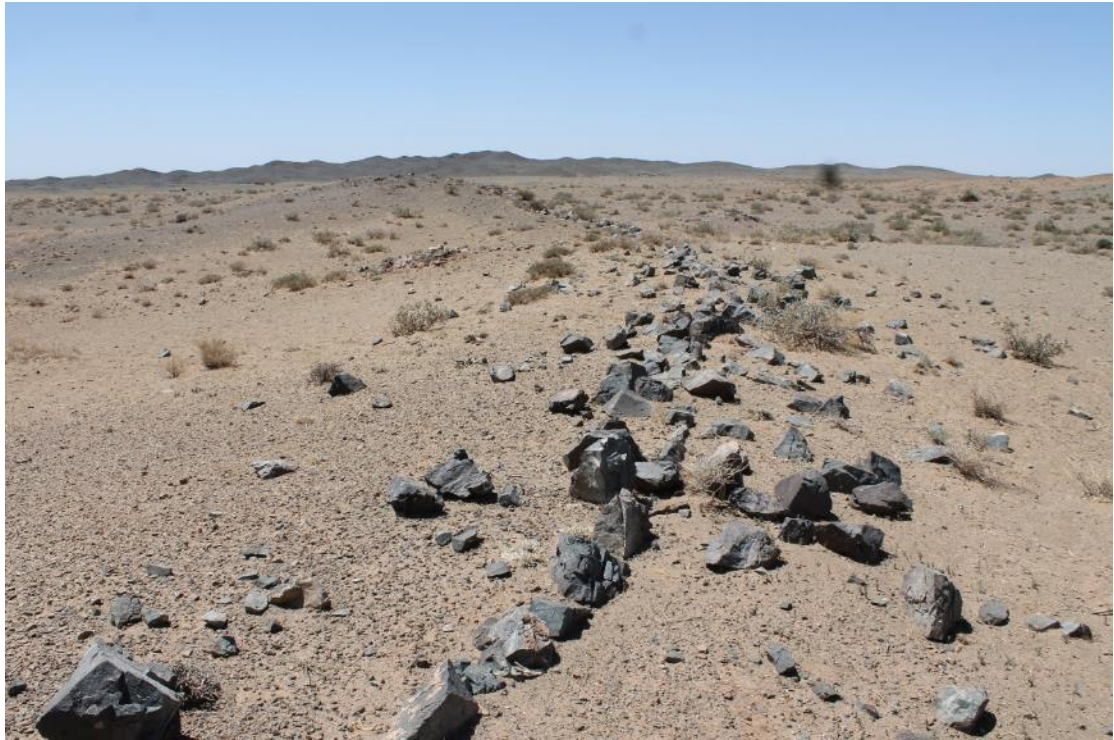
Fig. 3: The wall line northeast of enclosure G08. Coordinates: 42.47, 104.039

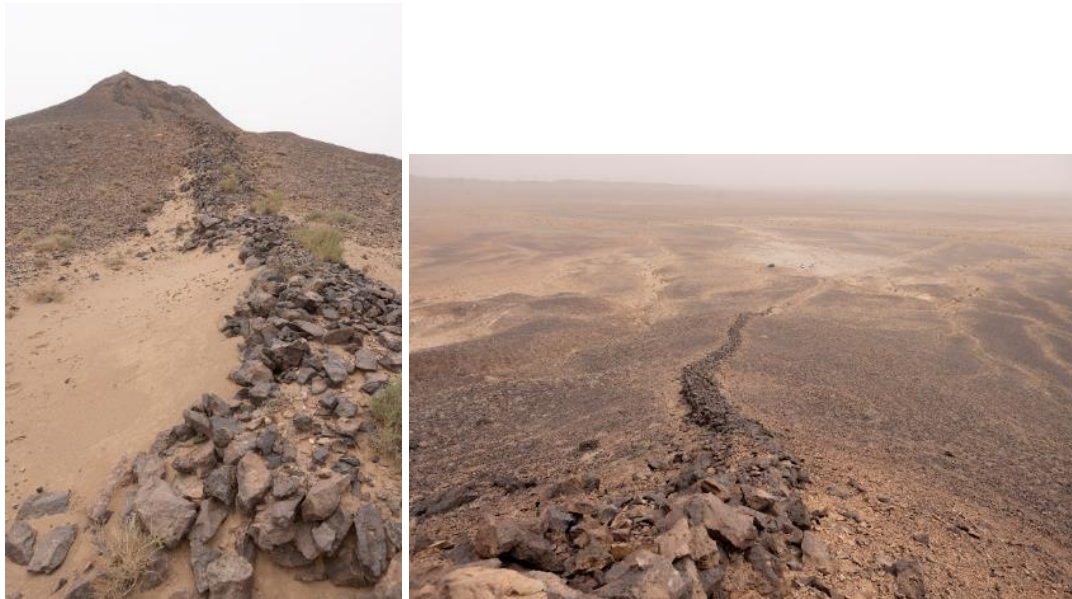
Fig. 4: Well preserve line of wall made of stone between coordinates 42.18166, 103.03747 to 42.17551, 103.02561

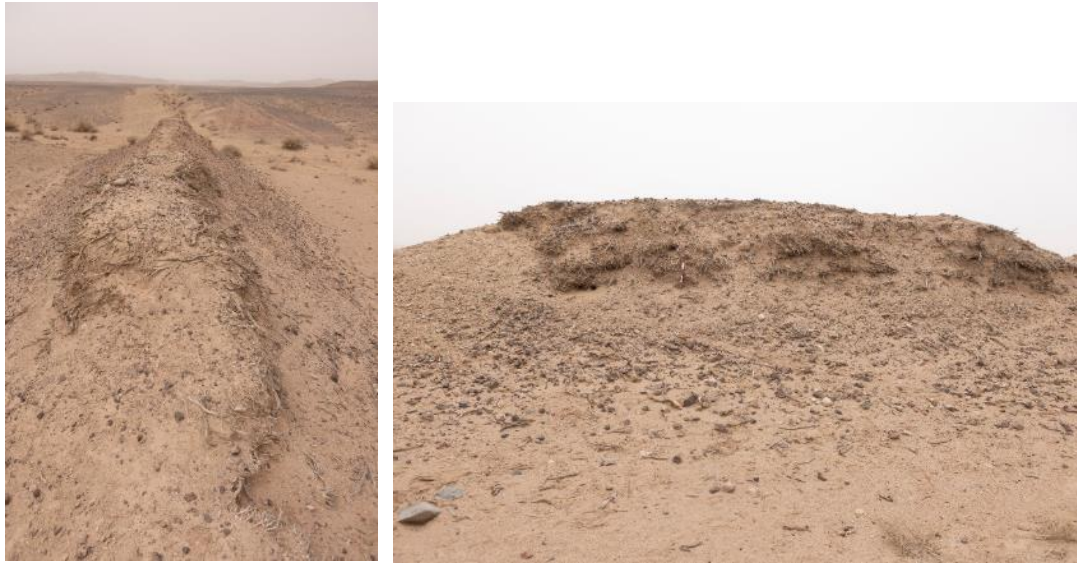
Fig. 5: A well preserved wall section made of wood and earth located around coordinates 42.19759, 103.13355.

At a few locations, especially in the western part of the Gobi wall section, the wall is built from wood, combined with stone and earth or wood and earth only. The best-preserved part that we located is around coordinates 42.19759, 103.13355. The wall here stands some 2m high and make an extensive use of wood branches (Fig. 5), but evidence for extensive use of wood (smaller and larger branches) was identified at other sections as well as in our excavations near enclosure G05. At none of the wall sections we surveyed we found any artifacts.

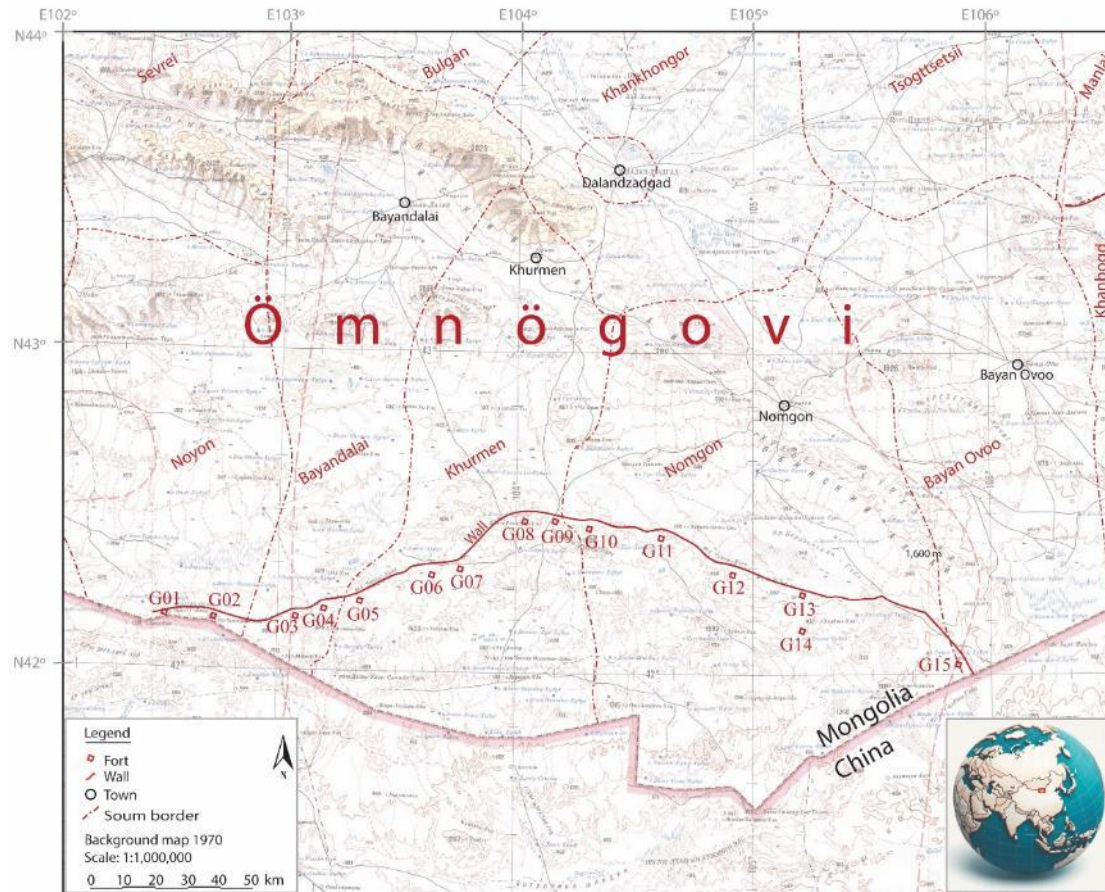
Fig. 7: The location of the rectangular enclosures along the wall-line (map by Dan Golan, background adopted form a Soviet map)

All together we identified 15 relatively large rectangular enclosures, identified as garrisons and marked G01-G15. (Fig. 7). One of those (G09) is questionable but the rest are clearly seen on the satellite images. Excluding G09, the garrisons range in size from 4,745 m<sup>2</sup> to 13,986 m<sup>2</sup>. Most of them are positioned with their corners oriented to the cardinal direction with some deviations (Fig. 6).

All the garrisons are located south of the wall line and most of them relatively close to it. The average distance between garrisons is 23km but some are much closer to each other (c. 12km) and others are more distant (c. 44km) (Fig 7 and table 1). During our expedition we visited ten of those sites, at two of them (G05 and G10) we conducted test excavations. Those will be discussed in the excavation section and the remaining seven (not including G09) are discussed below in consecutive order from west to east. In each of those sites we took drone photos of the site as well as regular photos of specific features, conducted intensive pedestrian survey inside and around the enclosures, and use a metal detector to uncover metal artifacts.

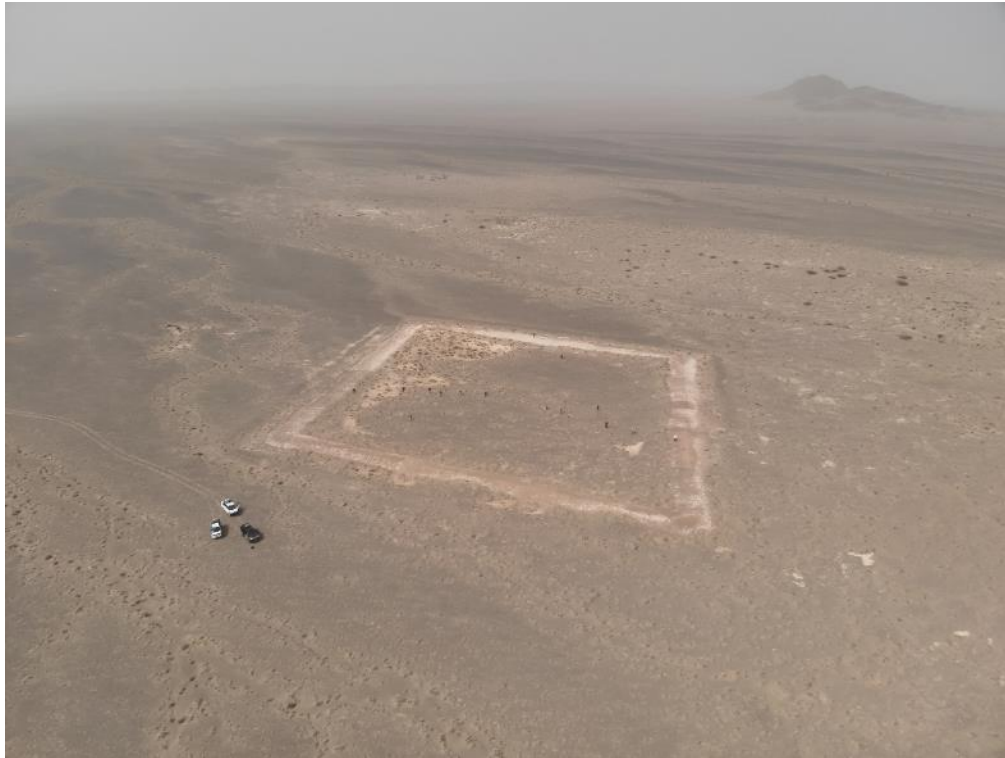
Fig. 8: G03 drone photo looking north

G03 (42.15132, 103.01183): This garrison is a trapezoidal shaped enclosure measuring 88x86m (internal diagonals 140m north-south and 120m east-west). The site was visited by Kovalev and Erdenebaatar (2021: 58) which marked it as Fortress no. 3. The earthen walls of the site are well preserved up to 1m high. The locations of corner towers are clear Figs. 8 & 9).

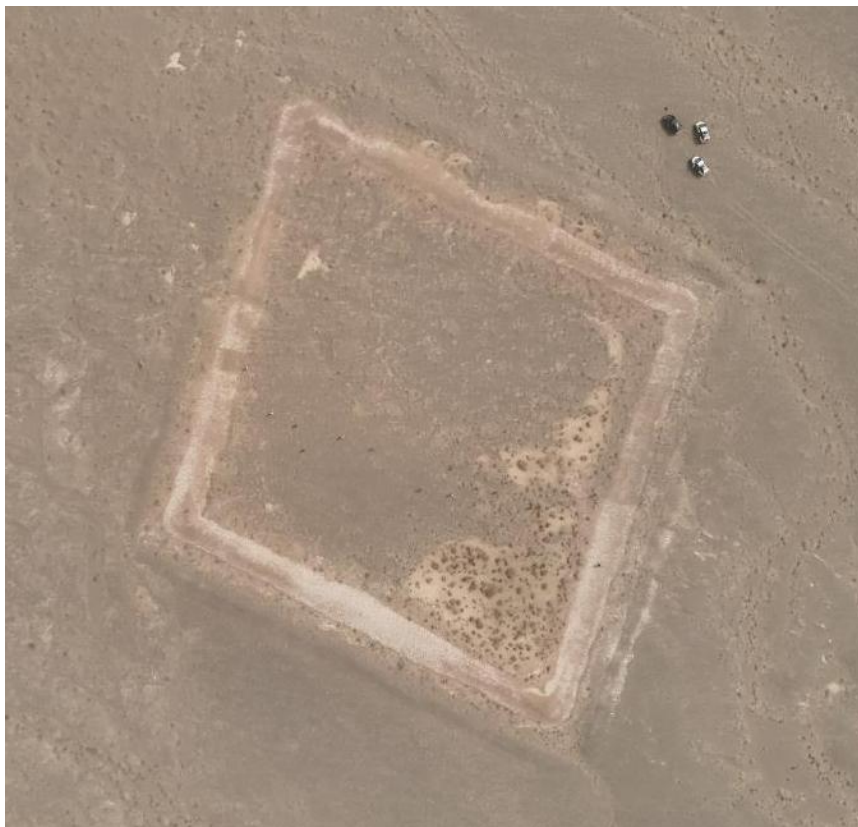
Fig. 9: G03 drone photo from above

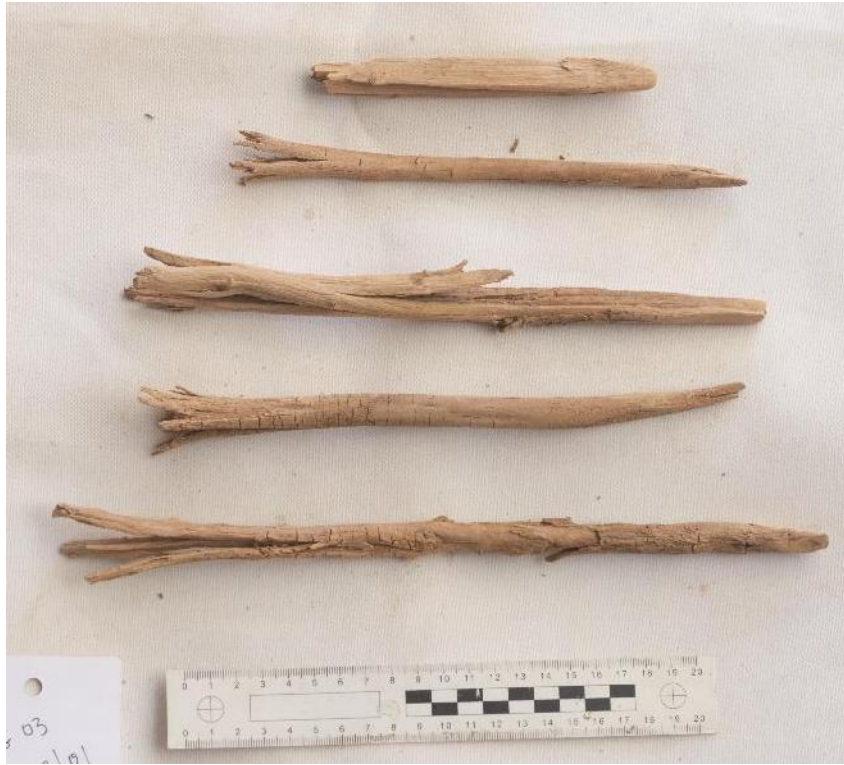
Fig. 11: Wooden stakes from site G03

Very few artifacts were found by our survey of the site. A black glazed base of ceramic vessel was found outside and north of the sites wall (Fig. 10a) and flint artifacts (Fig. 10b) were found south and east of the site walls. Finds unique to this garrison are wooden stakes (pegs) that were stuck into the garrison's walls. The stakes are about 20-30cm long with one side clearly pointed (Fig. 11). A sample of 5 stakes were taken for dating and tree identification. Previously, Kovalev and Erdenebaatar (2021: 66) dated one such wooden stake to  $780\pm30$  BP (AD 1219 to 1280AD). Another wooden sample they took from the same site provided a date of  $1135\pm20$  BP (AD 880 to 990).

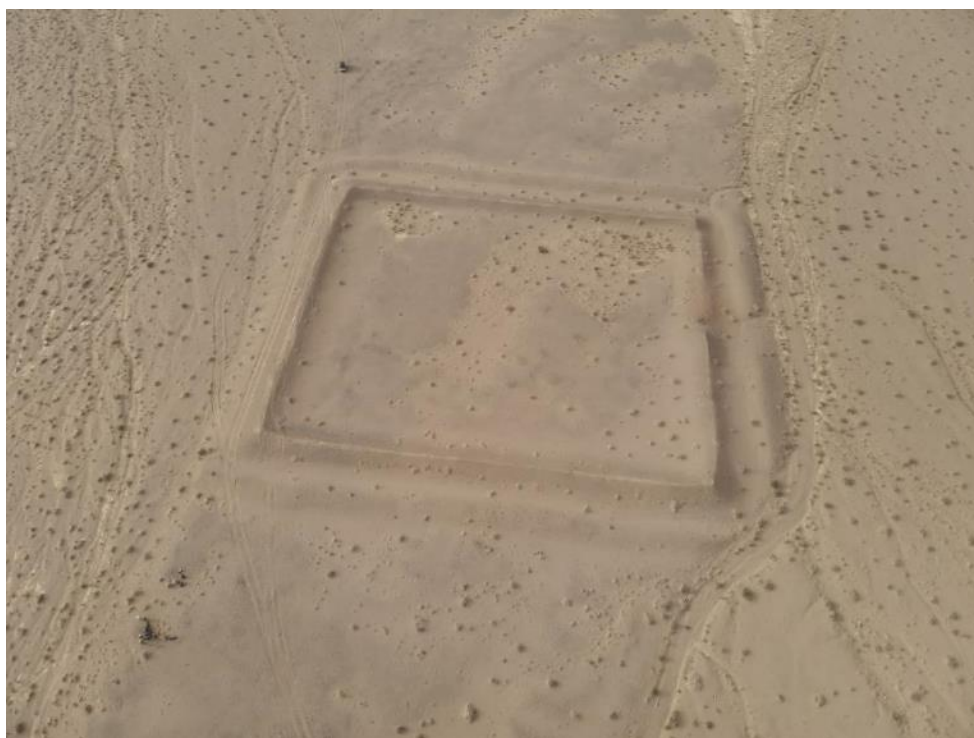
Fig. 12: Drone photo of G04

G04 (42.19178, 103.14206): This garrison was visited by Kovalev and Erdenebaatar (2021: 58) and labeled Fortress no. 4. It is a rectangular 85x98m in size. The walls are well preserved to about 1m high and they and the surrounding ditches that are highly visible (Fig. 12 & 13). A gate may have been located at the center of the eastern (southeastern) garrison's wall. Three small pieces of dark glazed pottery were found inside the garrison's walls (in the southern part). In spite of intensive Metal Detector survey, we did not find any metal artifact here.

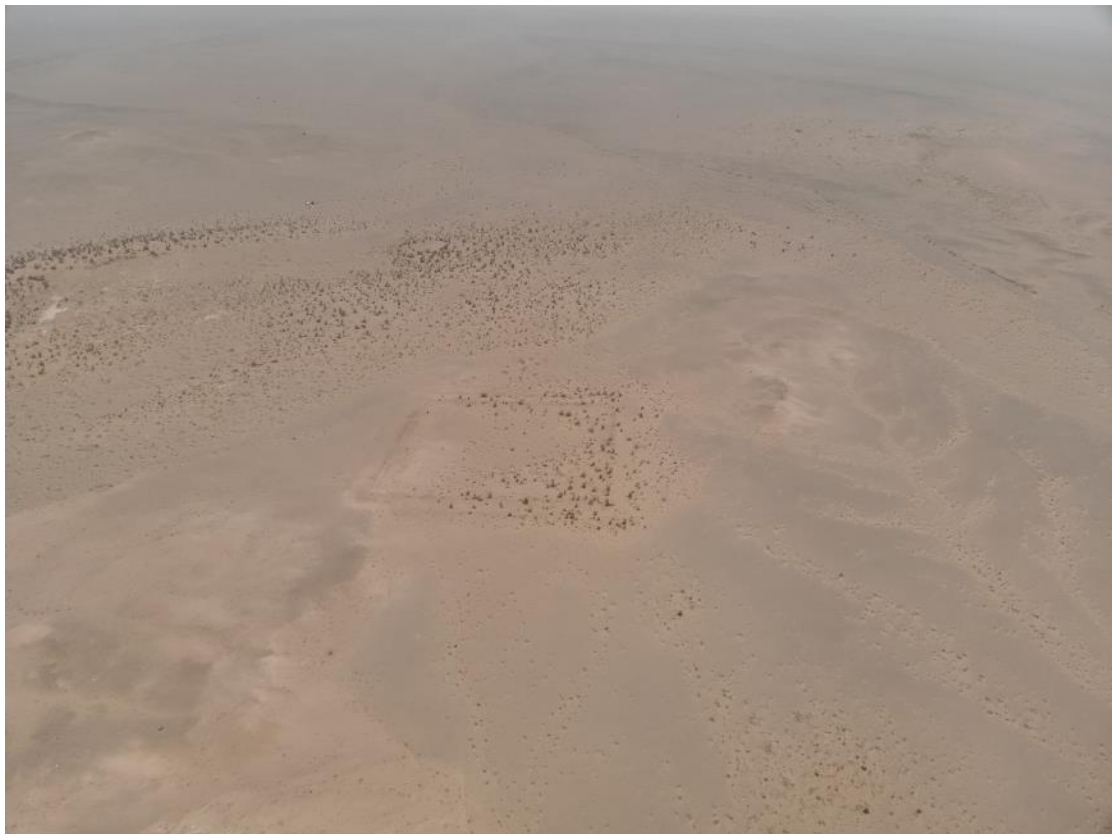
Fig. 14: Drone photo of G06 and its surrounded area

G06 (42.33963, 103.61582): This garrison was visited by Kovalev and Erdenebaatar (2021: 60) and labeled Fortress no. 6. Among all the garrisons we visited G06 is the best preserved. It is rectangular in shape 103x104m. The site and its surrounded area is partly covered by sand dunes but the wall are clearly visible and, in some places, stands some 2m high (Figs 14 & 15). A unique feature of this garrison is the exposure of the wood that were extensively used to construct the entire enclosing walls (Fig. 16). Our team cleaned a section at the northwestern enclosing wall. The section was some 0.5m and more than 1m deep which show the extensive use of wood (Fig. 17). Some of the timber used here was large wooden beams. We took samples of the wood from this section for dating and analysis (Fig. 18). Japanese–Mongolian team visited this site in 2012 and took wooden sample that was dated to 906±21 BP (AD 1044–1215) (Kovalev and Erdenebaatar (2021: 66).

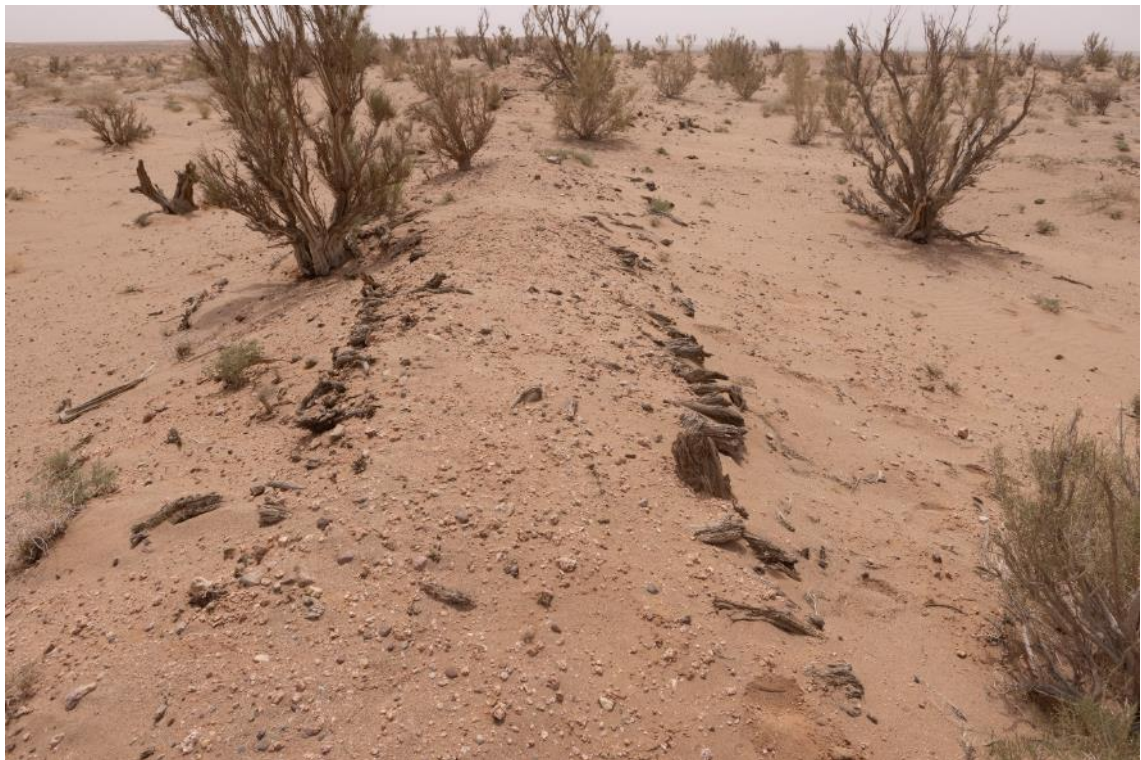
Fig. 16: Section of the enclosure wall of G06. The outer and inner faces of this wall are clearly made of wood.

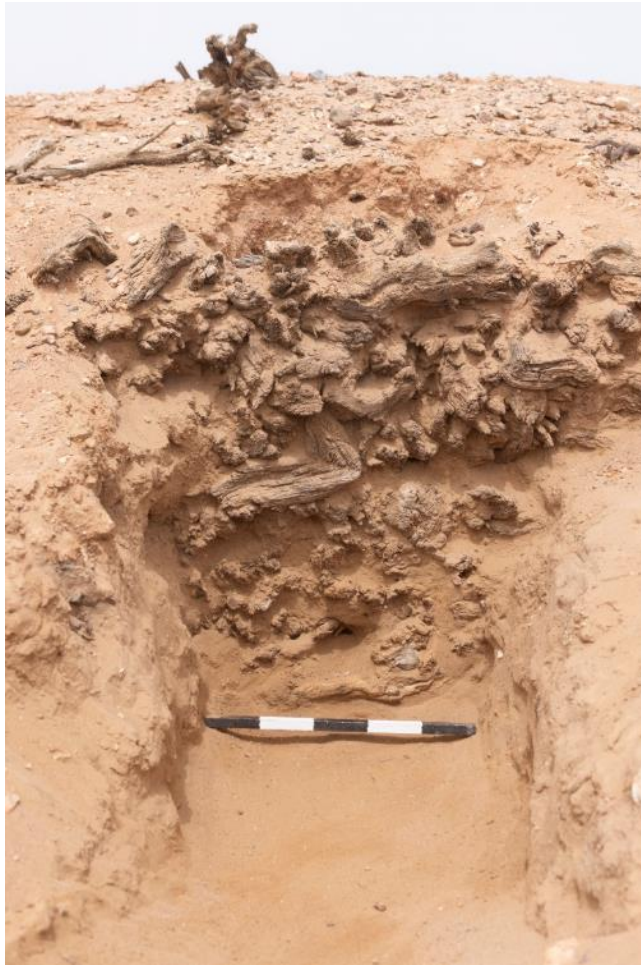
Fig. 17: Section of the enclosure wall of G06 cleaned by our team.

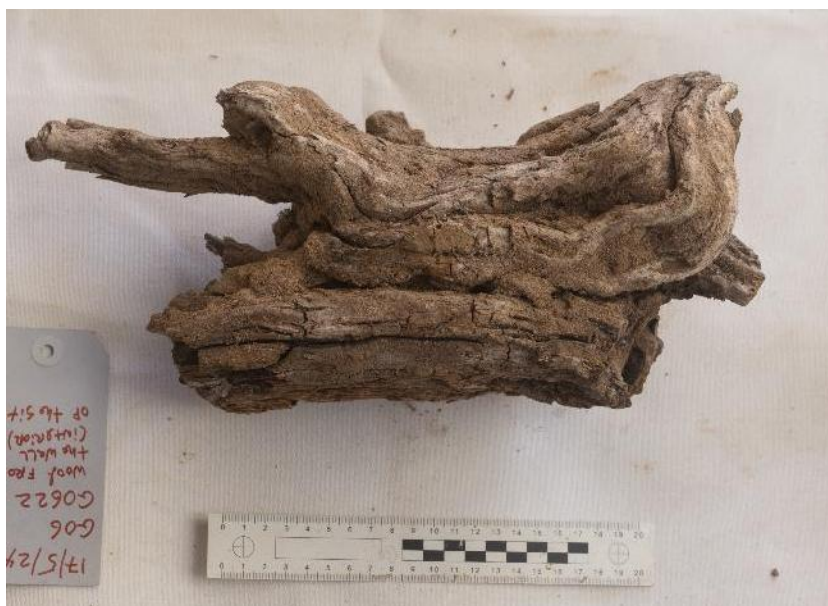
Fig. 18: A wooden beam from the walls of G06.

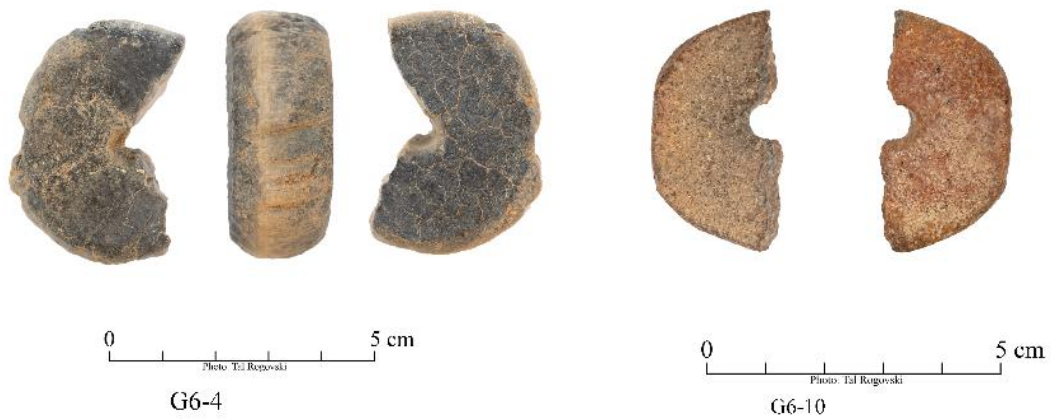
Fig. 19: Artifacts found at G06

Our survey of G06 uncovered one potshard, two ceramic spindle whorls (one was found outside the enclosure's walls), and three coins (Fig. 19). The shard is tentatively dated to the Xixia period. Two of the coins (Fig. 20) are dated to the Qing period – one to the Kangxi era (康熙, 1661-1722) and one to the Qianlung era (乾隆, 1735-1796).

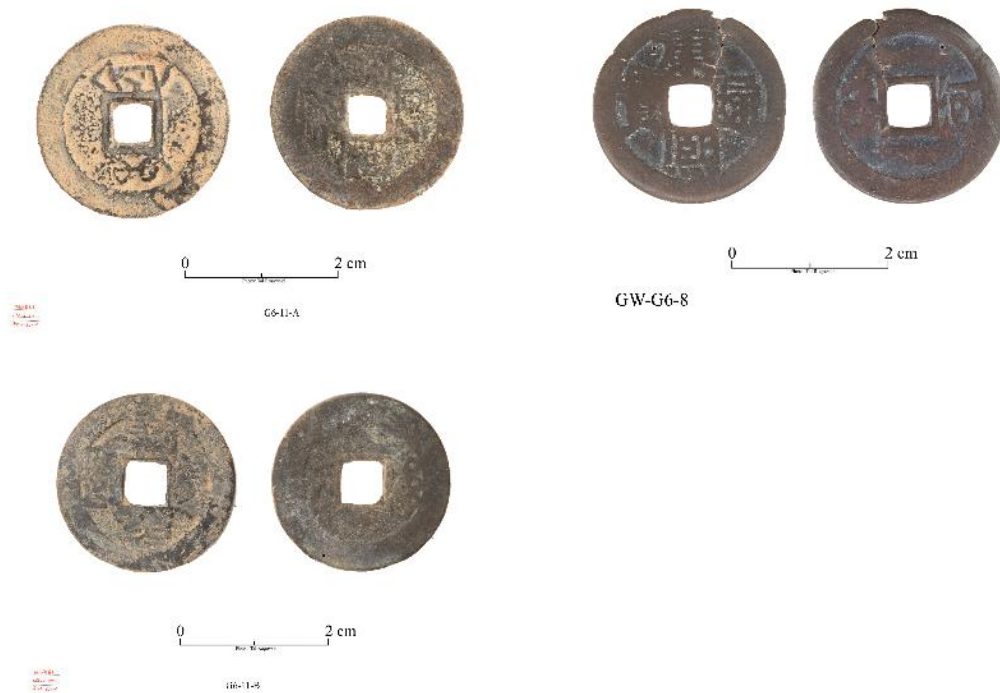
Fig. 20: Coins found at G06

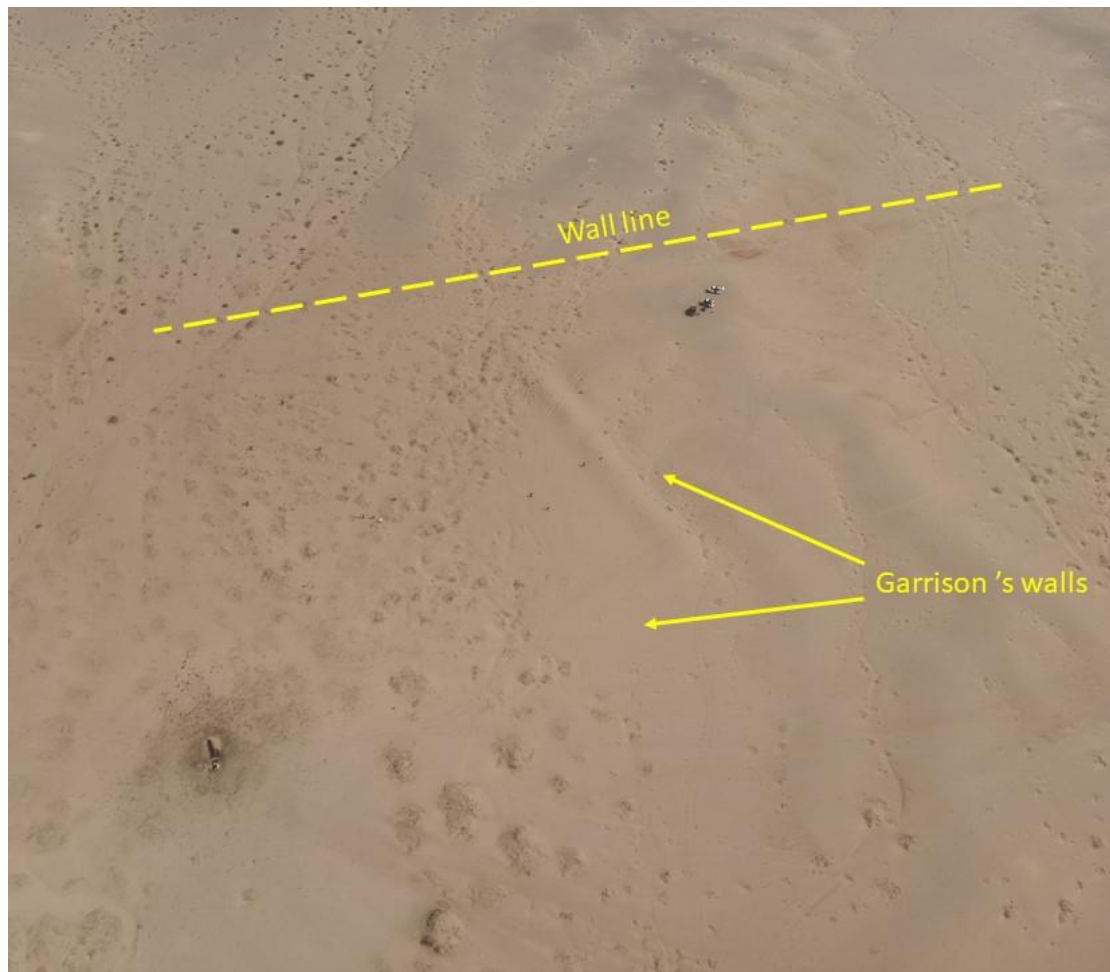
Fig. 21: A drone photo of G07

G07 (42.34569, 103.73799): This garrison was visited by Kovalev and Erdenebaatar (2021: 60) and labeled Fortress no. 7. Among all the garrisons this is the only one that is located practically adjacent to the wall line. It is a rectangular enclosure measuring 80x103m. Because of the sand coverage only the southeastern corner of the garrison is clearly visible (Fig. 21). However, taking Infra-Red images of this site we were able to see its structure more clearly (Fig. 22) Some twelve small ceramic and porcelain shards were recovered by our survey team from G07. Most are glazed some black and some white with brown-color line decoration (Fig. 23 ). Some of these shards were tentatively identified as Mongol period ceramics.

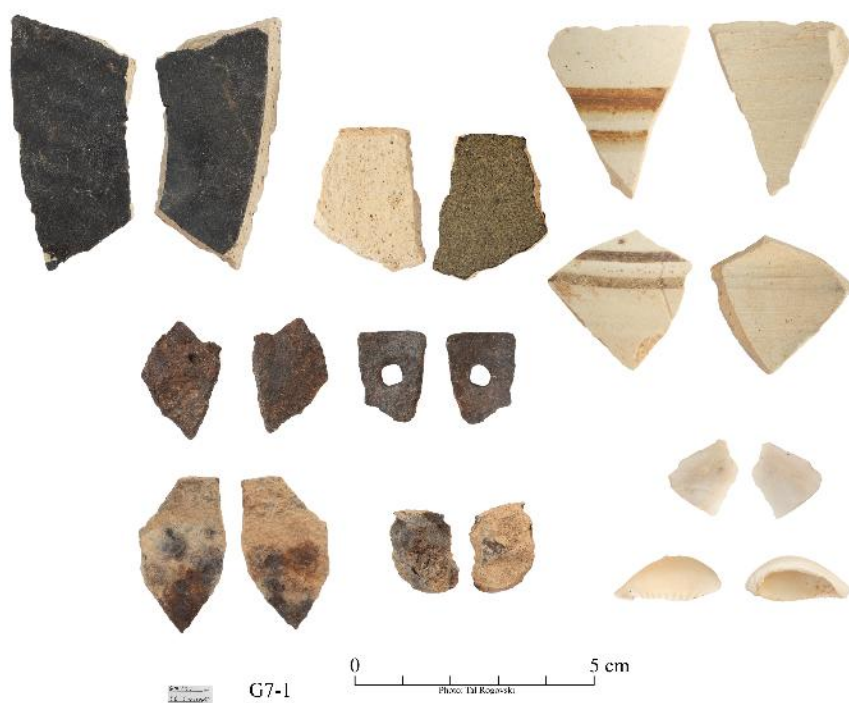
Fig 21: Shards and other artifacts recovered from G07

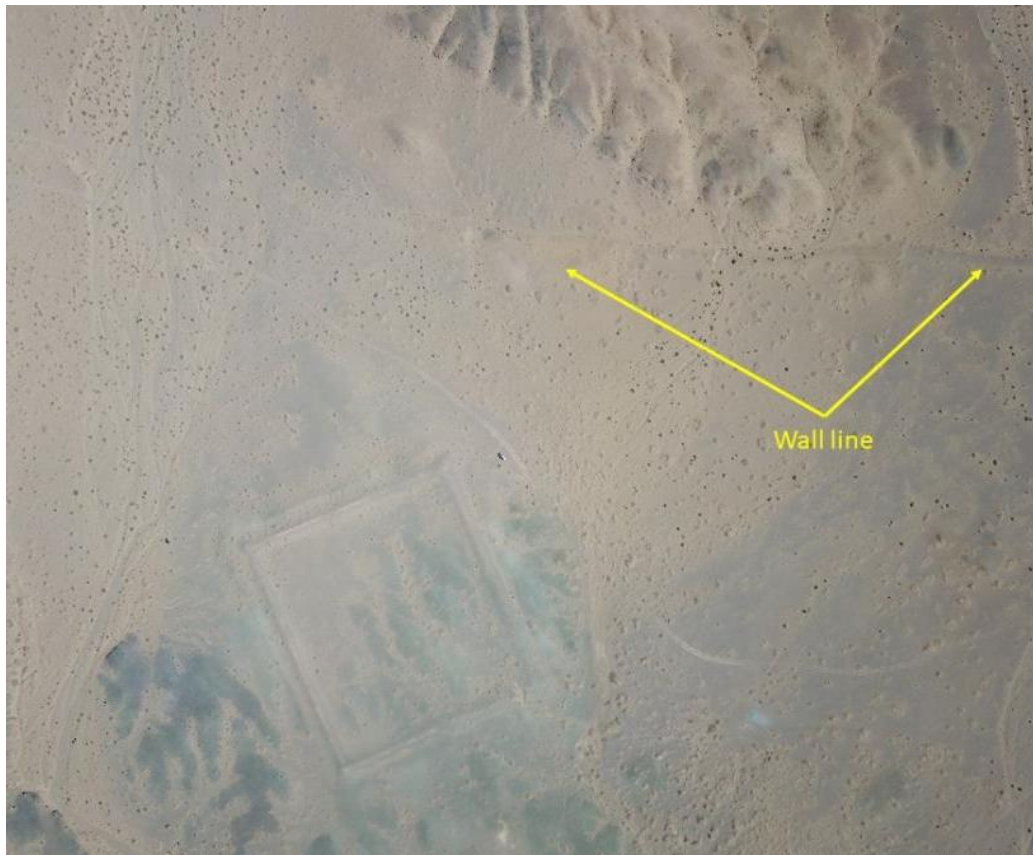
Fig. 24: A drone photo of G08 and the wall line north of it.

G08 (42.47144, 104.03172): This garrison was visited by Kovalev and Erdenebaatar (2021: 60) and labeled Fortress no. 8. The garrison's size is 108x125m. This garrison is well preserved with its ditch and corner towers clearly visible. It is located relatively close to the wall line which is also relatively well preserved in this area (Fig. 24). A relatively large number of small shards, most of them black glazed, were recovered from different parts of this enclosure (Fig 25). Some of them have been tentatively identified (by Chinese archaeologists) to the Xixia period and others that may be modern.

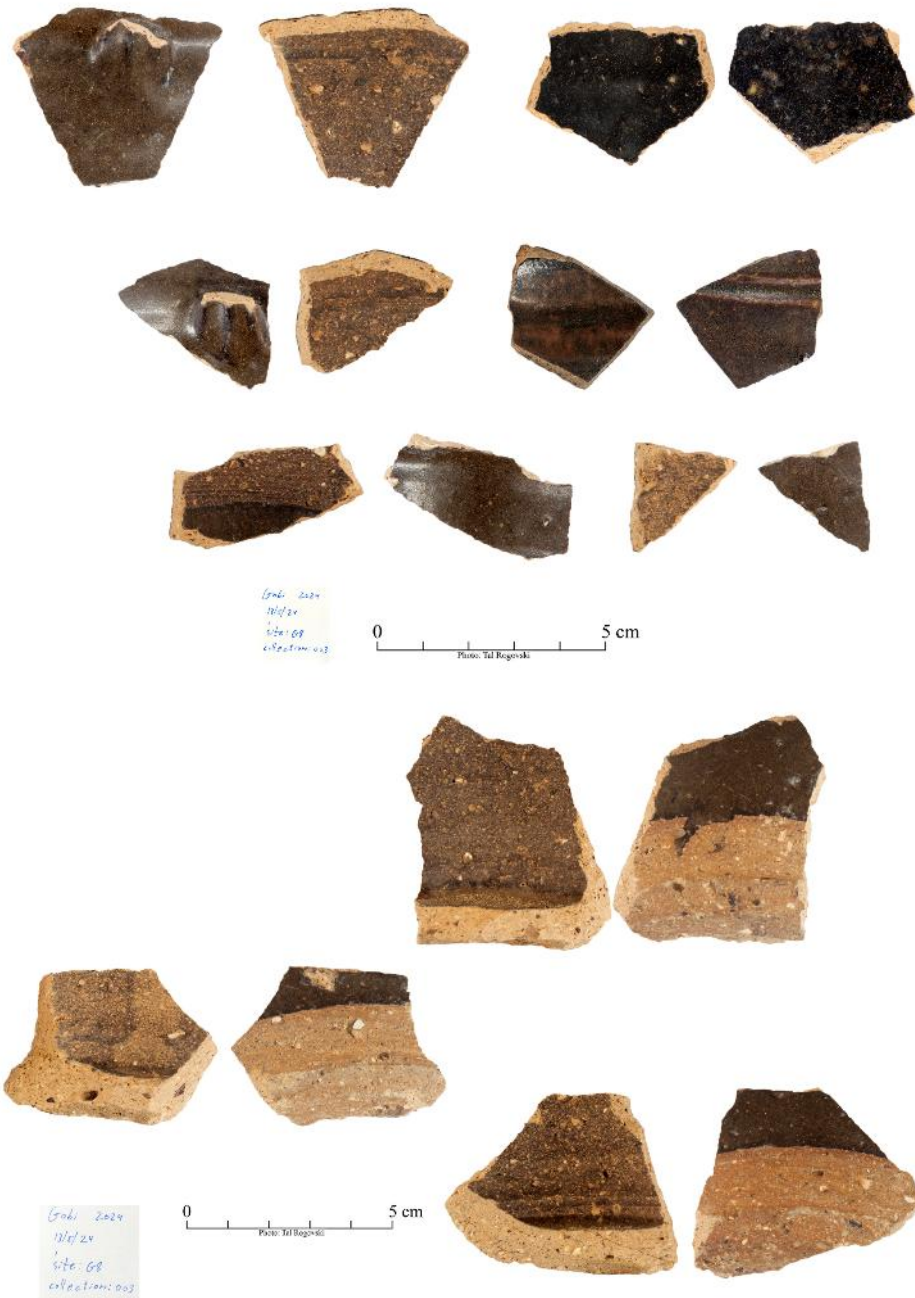
Fig. 25: Shards recovered from G08.

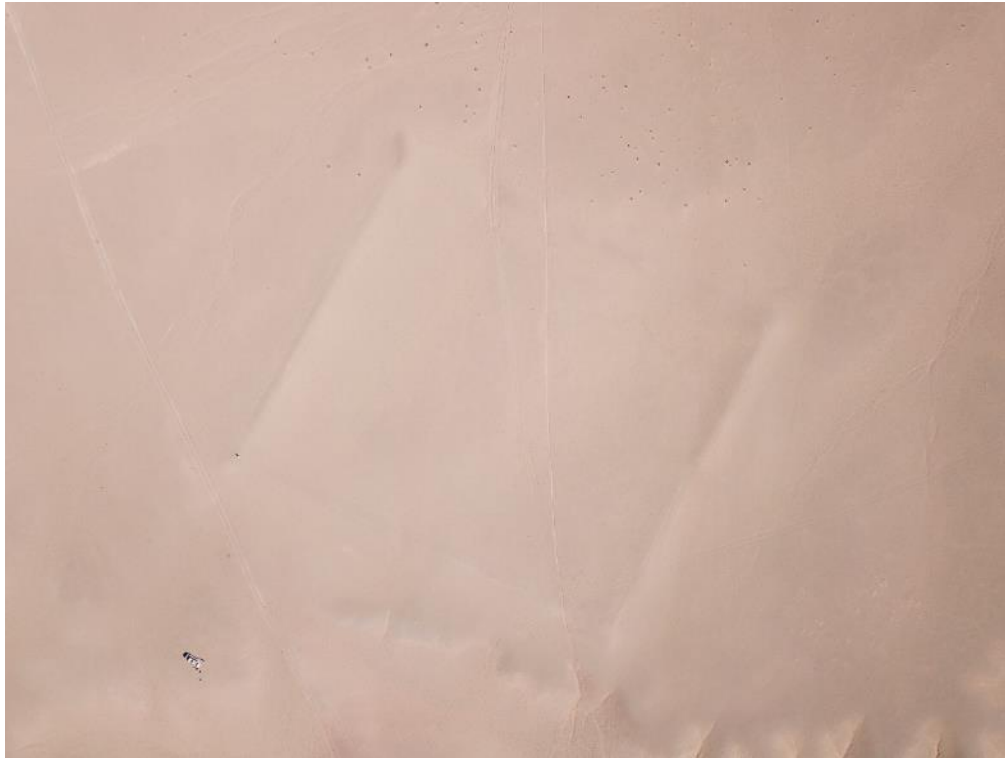
Fig. 26: A drone photo of G11

G11 (42.43807, 104.66517): This garrison was visited by Kovalev and Erdenebaatar (2021: 60) and labeled Fortress no. 10. The garrison's size is 110x132m. It is relatively eroded and partly covered with sand (Fig. 26). In spite of intensively surveying inside and outside the garrison's walls we were able to find only one stone artifact and not shards.

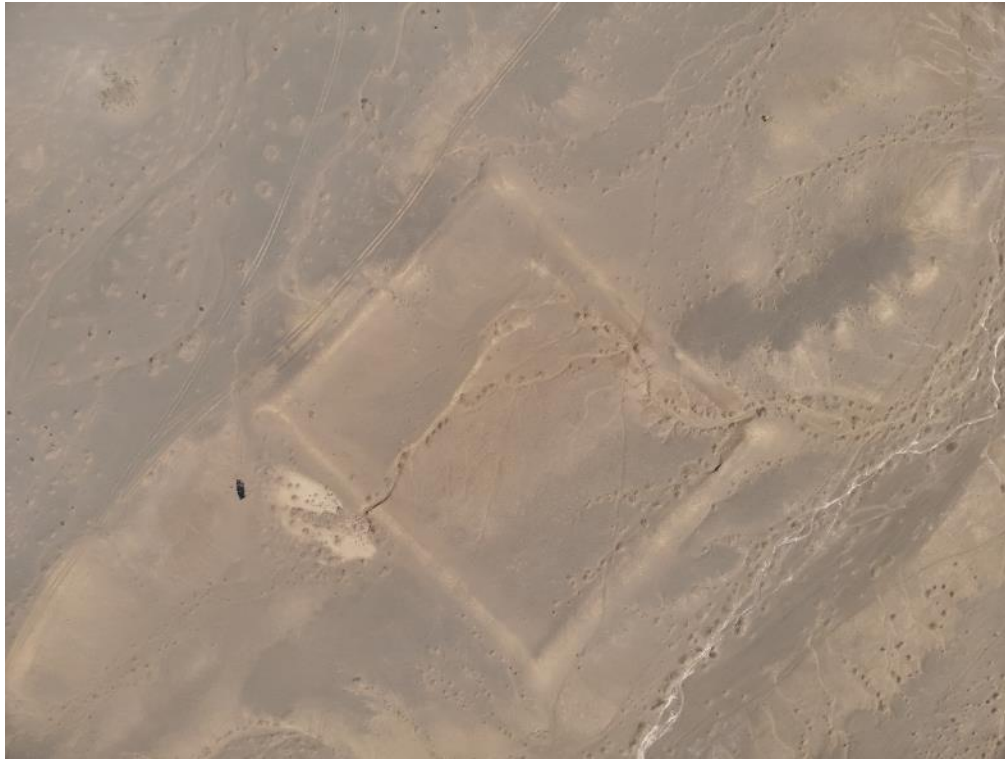
Fig. 27: A drone photo of G12

G12 (42.31544, 104.99789): This garrison was visited by Kovalev and Erdenebaatar (2021: 60) and labeled Fortress no. 11. The garrison's size is 111x136m. The walls of this garrison are relatively well preserved with the corner towers and enclosing ditch highly visible (Fig. 27). In spite of intensively surveying inside and outside the garrison's walls we were unable to recover any artifact.

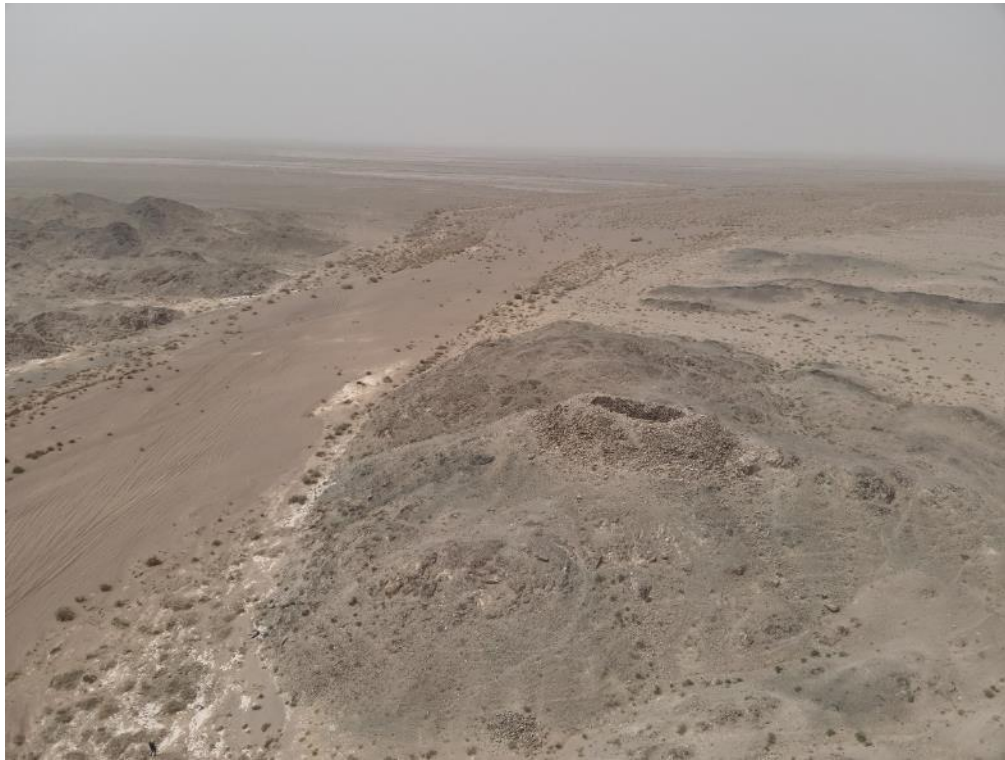
Fig. 28: A drone phot of F41 looking northwards showing the position of the fort east of the river and close to its norther entrance into the mountain range area.

F41 (42.19413, 102.97452): Located on top of a hill situated on the eastern side of a dry river that cut through the mountain ridge (Fig. 28). The fort control the natural route that passes through the mountain ridge (Fig. 29). This site is described by Kovalev and Erdenebaatar (2021: 64). They name it Fort 1, Shivee khatavch. It is a small elliptic shape structure. The internal space is some 13m from east to west and 4.5m north-south. In the inside the built walls erect stone walls are clear but, on the outside, there is a larger spread of accumulated stones – perhaps as a result of the collapse of

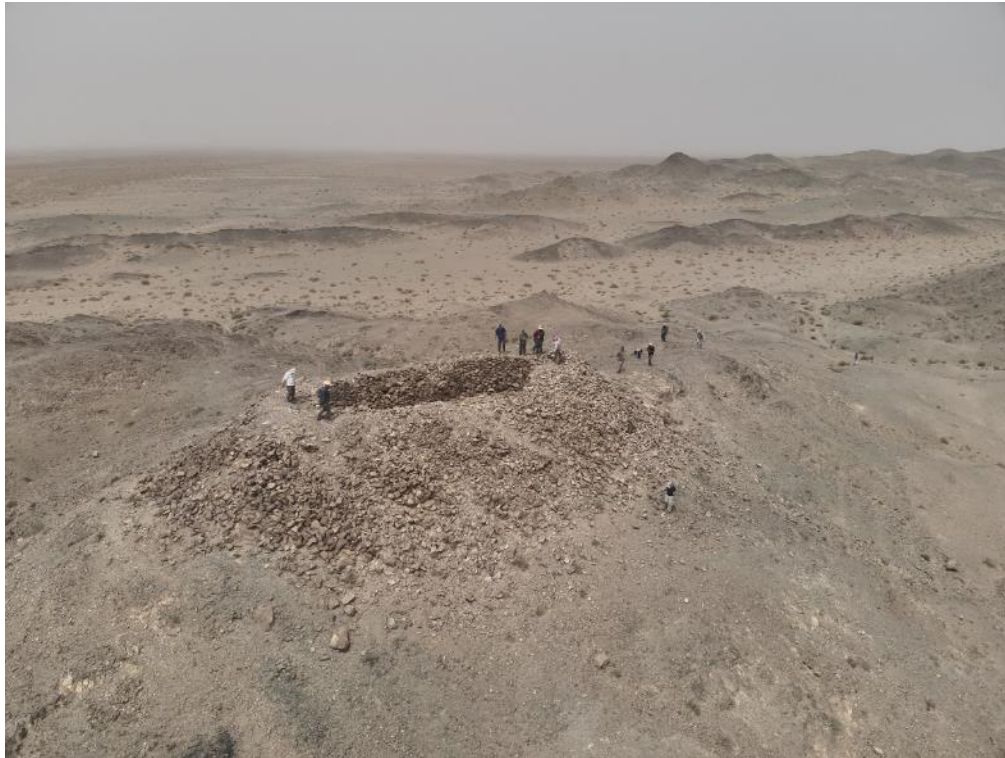
Fig. 30: A drone phot of F41.

the walls or perhaps representing a larger foundation ramp on which the fort was built (Figs. 30 and 31). On the inside the walls are preserved to about 1-2m high but they are much higher on the outside. No artifacts were found inside or around F41 and no materials for dating either.

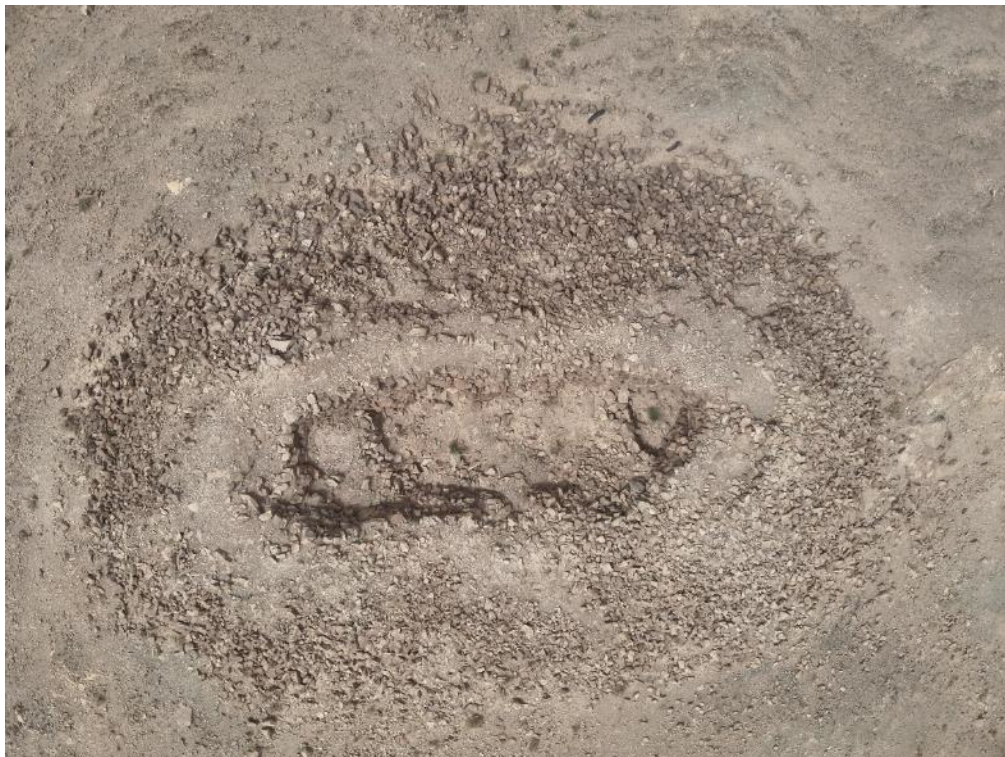
Fig. 31: A drone phot of F41 (a view from above).

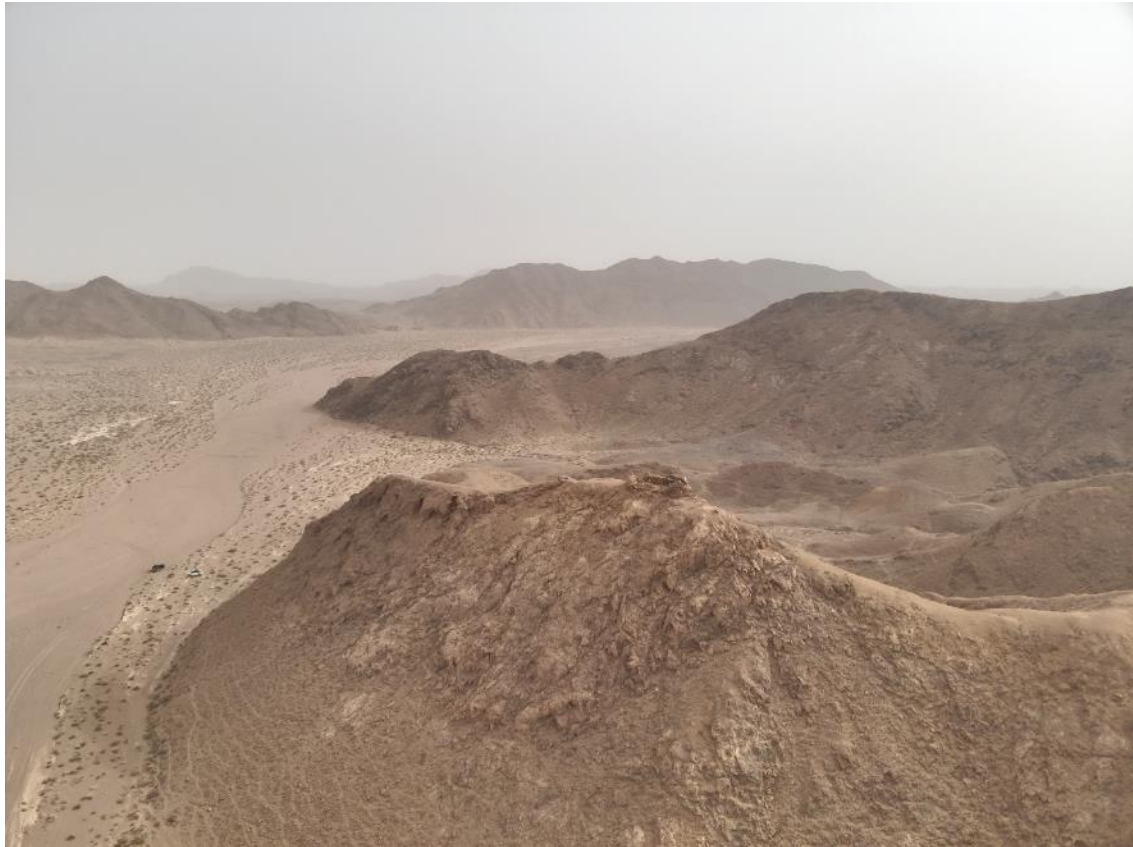
Fig. 33: The location of F42, a look southwards towards the pass between the steep mountains.

F42 (42.01893, 103.26533): Located on top of a hill situated on the western side of a dry river that cut through the mountain ridge. It is located on the northern entrance to a steep section which is the southern terminus of this pass (Fig. 32). The location of the fort is high above the river bed (Fig. 33). This site is described by Kovalev and Erdenebaatar (2021: 64). They name it Fort 2. Like F41 this is an oval shaped structure. Its internal size is about 14 m (north-south) and 7m (east-west) (Fig. 34). Unlike F41 the internal and external faces of the walls are visible and the wall is some 2m wide and stand to about 3m high at the highest places (Fig. 35). Unlike the walls of F41, wooden beams are integrated inside the stone construction of the walls of F42. The wooden beams, some of them relatively large, are integrated with the unworked stones (Fig. 36). We took a sample of wood for dating and analysis (Fig. 37). No other objects were found in or around F42.
