## Report on work done in Ömnögovi Province, Mongolia, June 8-23, 2024

As part of The Wall project, a collaboration between the Hebrew University, National University of Mongolia and Yale University, we conducted a field work in Ömnögovi Province. The work was focused on a line of wall located parallel to the Mongolia-China border and on structures of different kinds located along this line and in its vicinity (Fig. 1). The wall-line is stretching, in an arc shape, from point 42.17358, 102.41393 in the west to point 41.986, 105.87545 in the east. This wall line was already identified by Baasan (2008: 73). An extensive survey of this wall line and associated structures was carried out, between 2005 to 2012, by Erdenebaatar Diimaajav and Alexey Kovalev and by the Joint Mongolian – Japanese team (Kovalev and Erdenebaatar 2021; Moriya et al., 2014). In the east this wall line continues into China where it was extensively surveyed by Chinese archaeologists (Wei 2010; Zhang 2023).

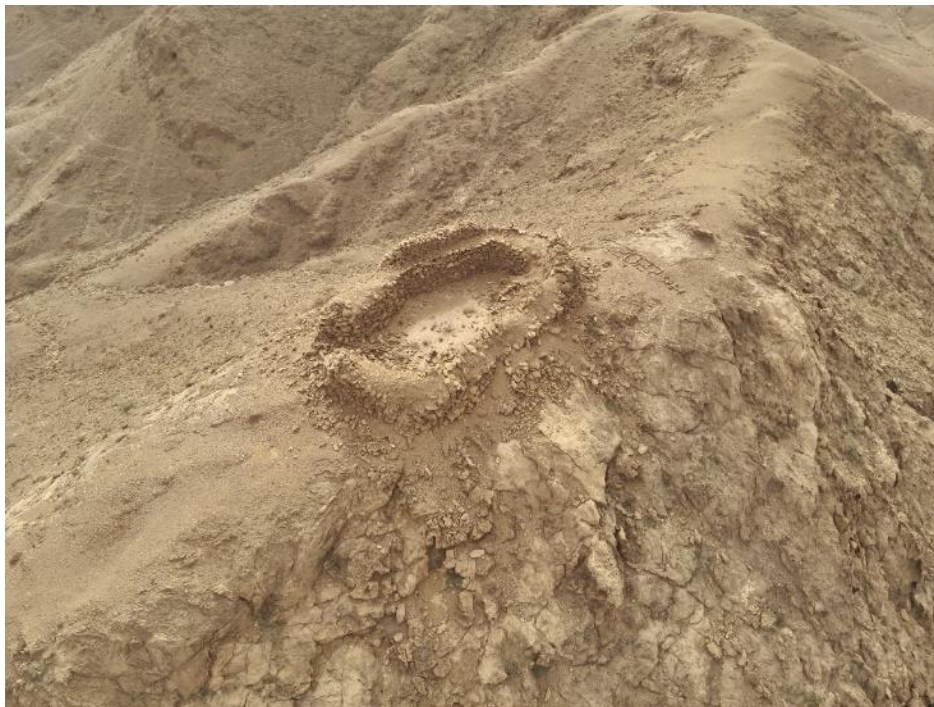
Fig. 34: A drone photo of F42.

F42 (42.01893, 103.26533): Located on top of a hill situated on the western side of a dry river that cut through the mountain ridge. It is located on the northern entrance to a steep section which is the southern terminus of this pass (Fig. 32). The location of the fort is high above the river bed (Fig. 33). This site is described by Kovalev and Erdenebaatar (2021: 64). They name it Fort 2. Like F41 this is an oval shaped structure. Its internal size is about 14 m (north-south) and 7m (east-west) (Fig. 34). Unlike F41 the internal and external faces of the walls are visible and the wall is some 2m wide and stand to about 3m high at the highest places (Fig. 35). Unlike the walls of F41, wooden beams are integrated inside the stone construction of the walls of F42. The wooden beams, some of them relatively large, are integrated with the unworked stones (Fig. 36). We took a sample of wood for dating and analysis (Fig. 37). No other objects were found in or around F42.

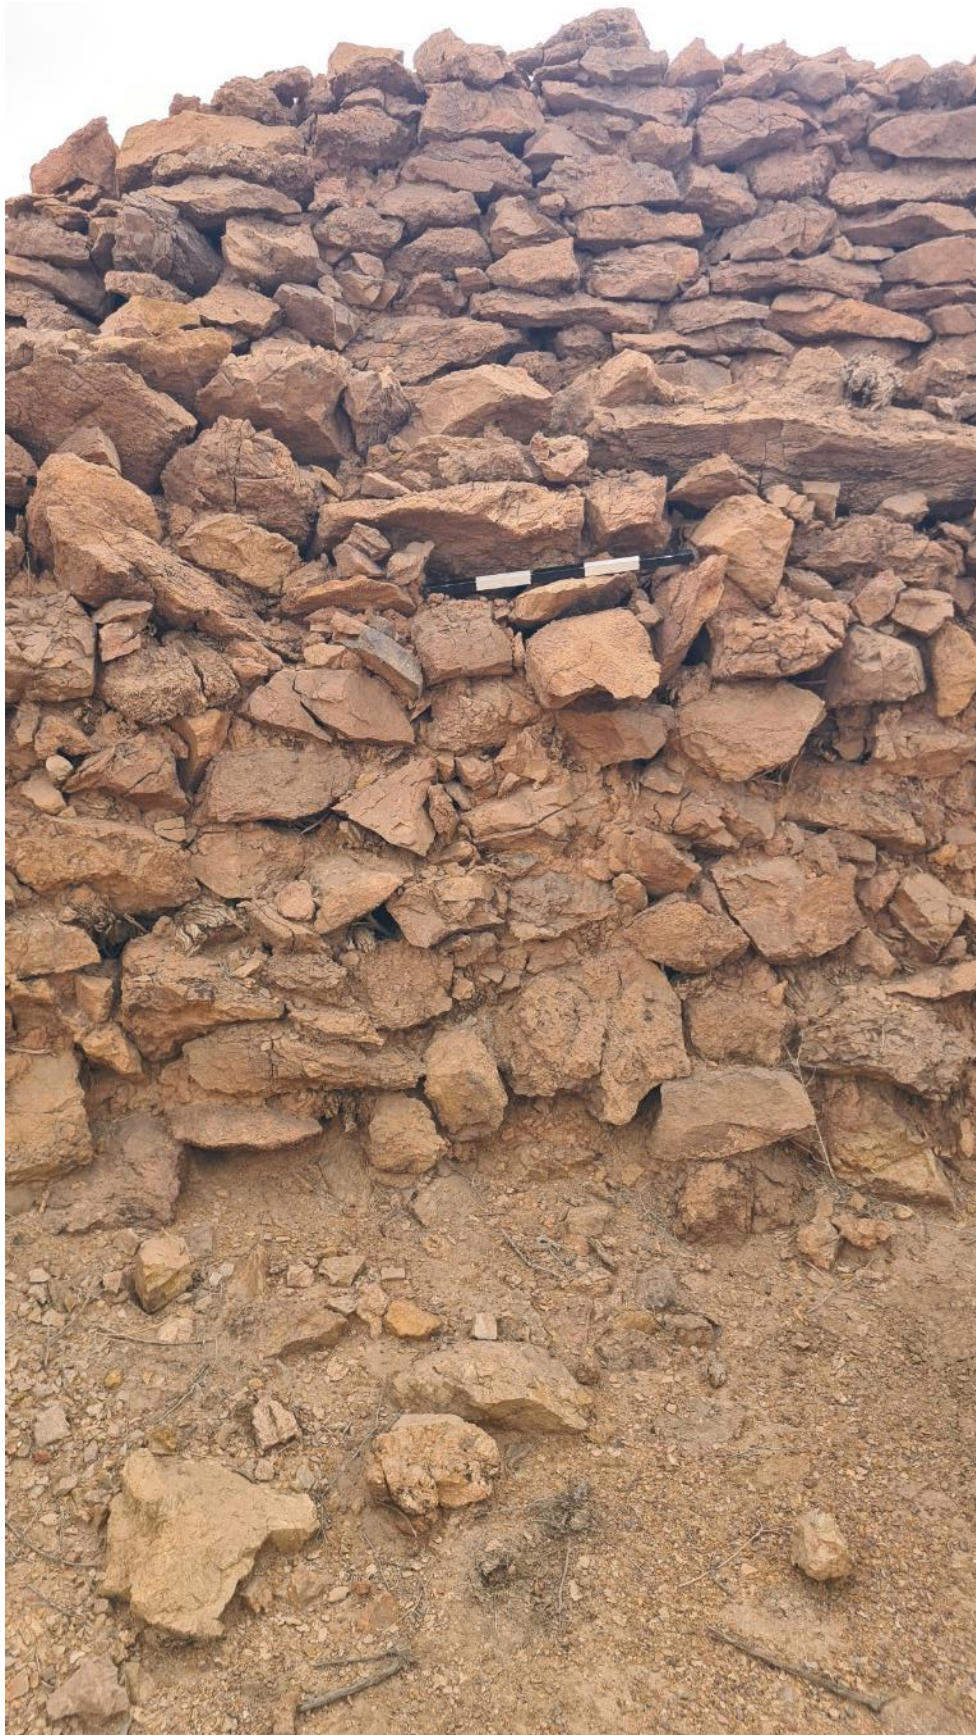
Fig. 35: The walls of F42 from the inside. The location of the wood sample we took is marked by the yardstick

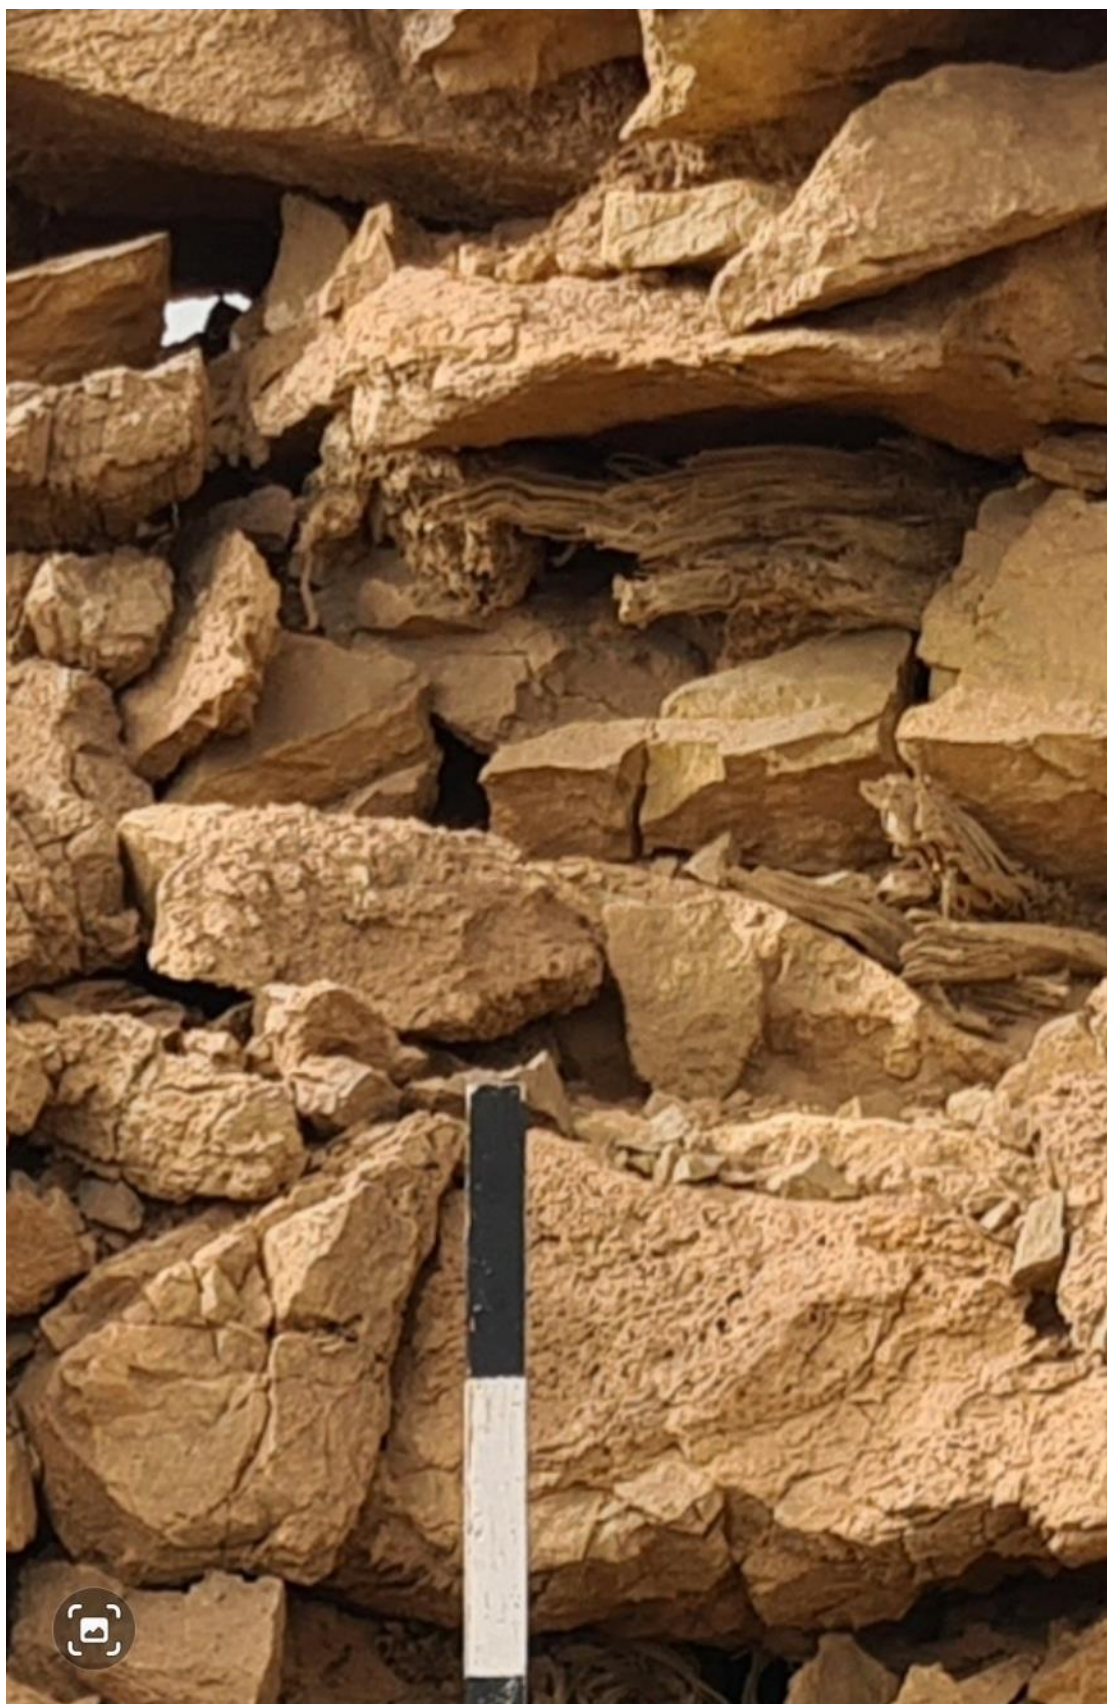
Fig. 36: Wood integrated inside the stones of the walls of F42

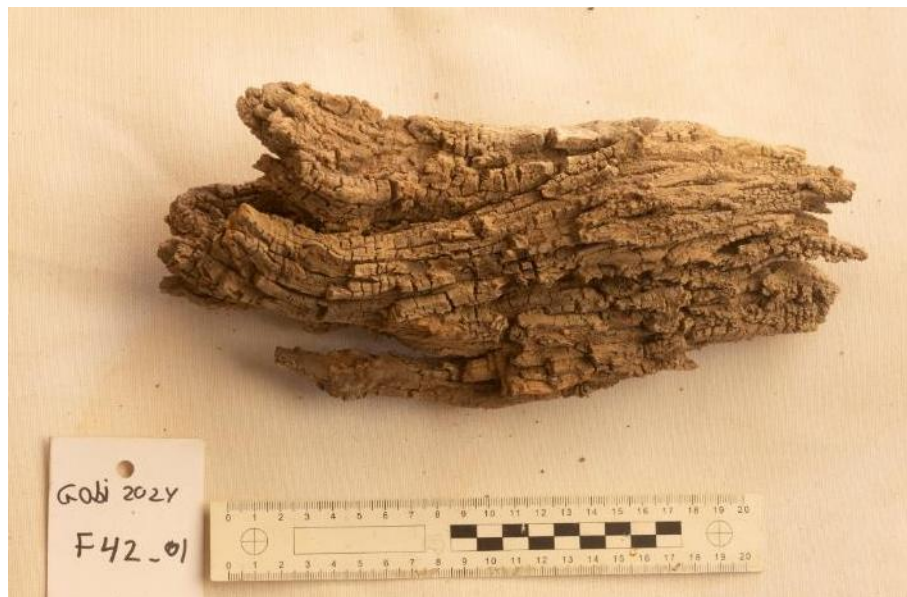
Fig. 37: A wood sample taken from F42

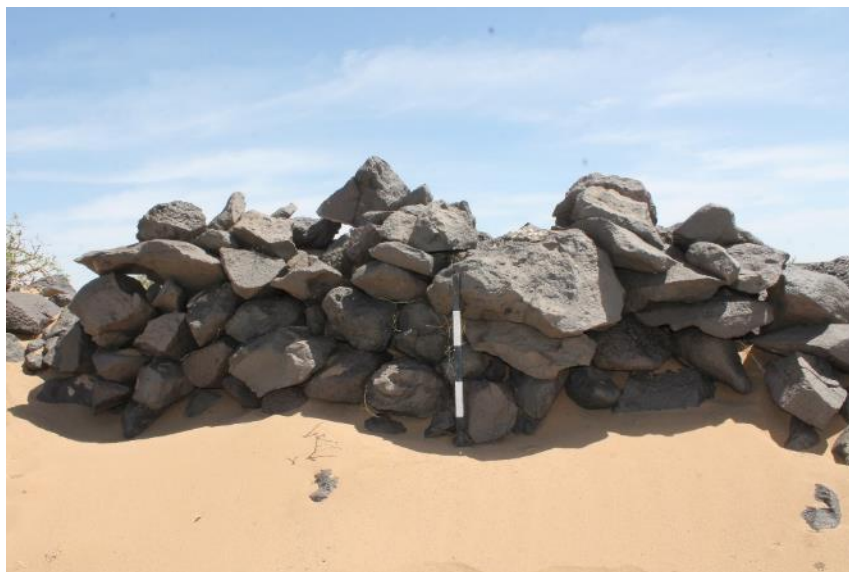
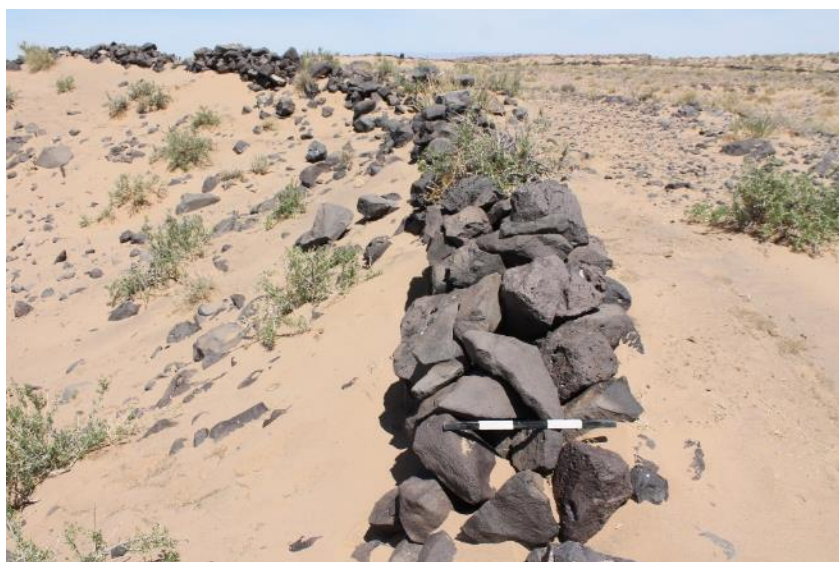
Fig 39: The enclosure's wall

The stone enclosure is 120m wide on the cliff side and some 195m from the cliff to the further point up hill. It encloses an area of 656 m<sup>2</sup>. From the cliff the wall on both sides climbs steeply until it reaches a relatively flat area, where it continues to enclose a large space. On the south – southwestern side it follows more or less the outline of the slopes and to the north and west it is connected to the rest of the mountain range. The wall of the enclosure is made of unworked stones. It is preserved a few courses high – some 0.5m in some places (Figs 39). Gates are one of the most interesting features of the enclosure's wall. We located two well preserved such gates on the northern wall of the enclosure and more may have been on the southern and western side but they are not clear. The gates are a simple version of 'baffle gate' with external and internal gate walls and openings in 90 degrees angle (Fig 40). We intensively surveyed inside the enclosure but did not find any artifact. On one of the stones that are part of the natural cliff at the southeastern side of the site we found a petroglyph of a horse (Fig. 41).

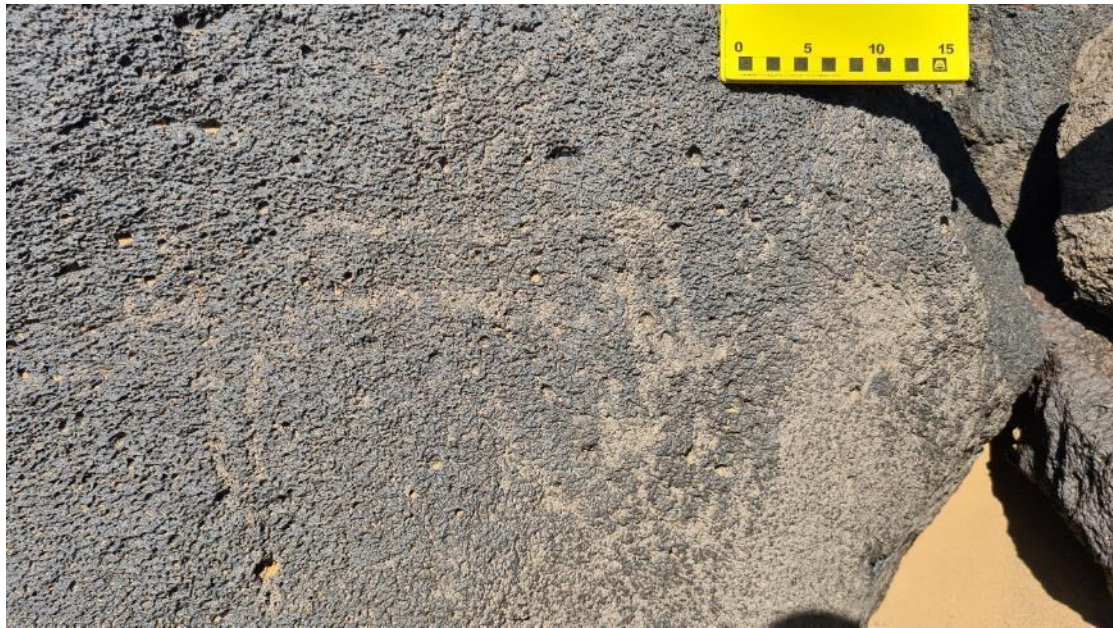
Fig. 41: A horse petroglyph

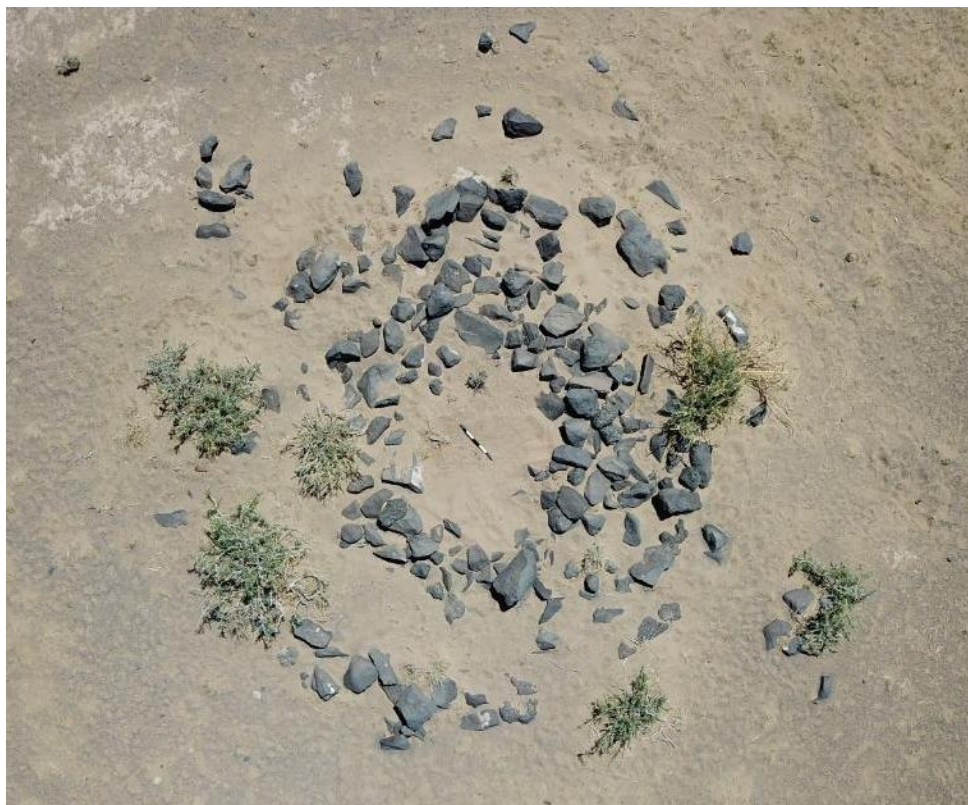
Fig. 42: A drone photo of the grave

North of the enclosure there is a large circular stone pile made of at least two concentric circles (Fig. 42). The structure is located in a low ground between the enclosure to the south and a lower ridge to the north. In this area we found a relatively large number of black glazed ceramic shards, some of them quite large. It seems that the structure is a grave and the pottery may have been originated from it or related to it (Fig. 43).

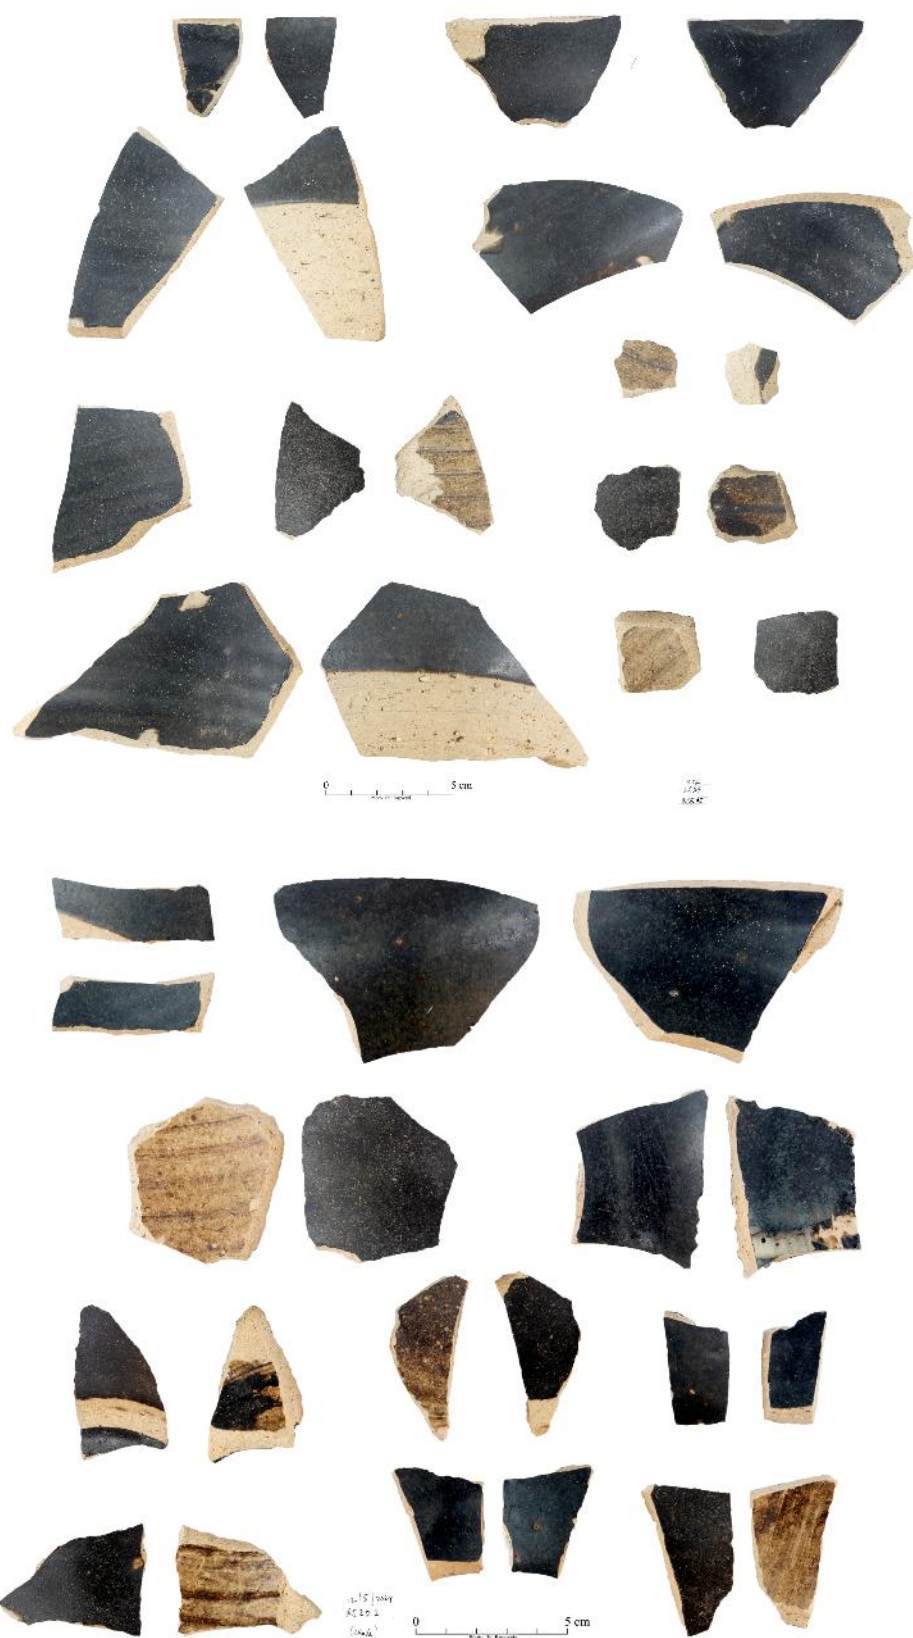
Fig. 43: Some of the ceramic found in the area of the grave

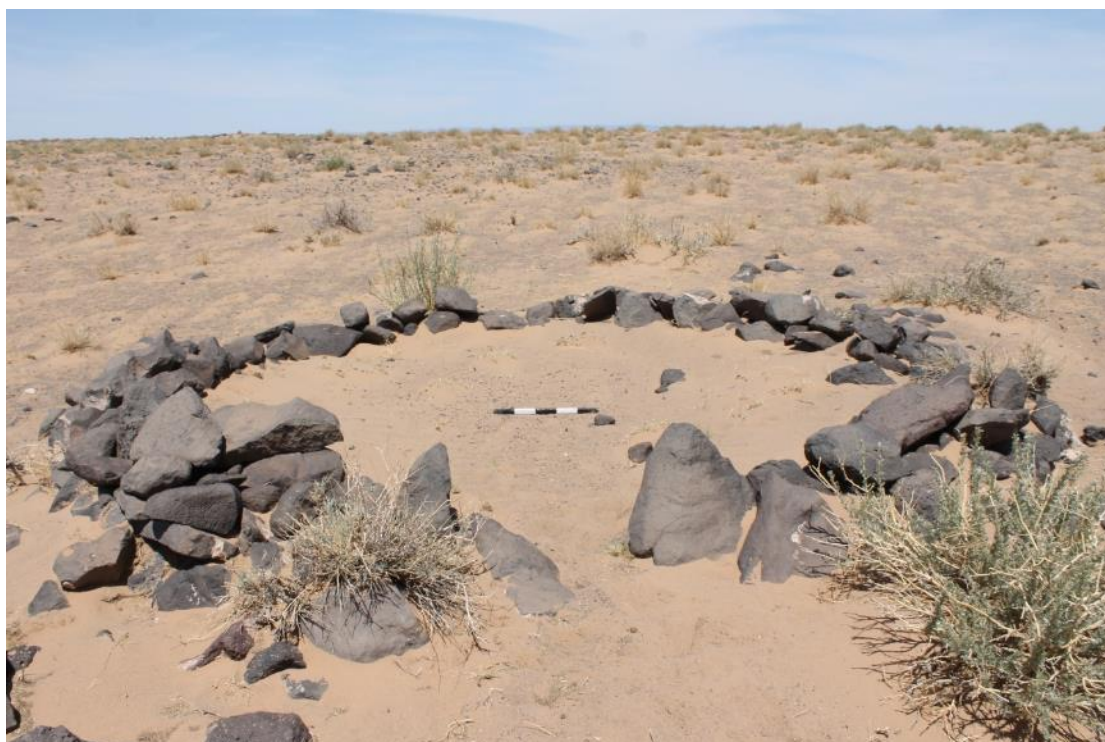
Fig. 44: A circular stone structure

North and west of the grave we uncovered a large number of circular structures ranging in size from 3 to 4m diameter. Some of those structures are connected to each other. Most of the structures have a clear opening in their walls, suggesting that those were the 'doors' to domestic structures (Fig. 44-45). Our survey counted some 28 such circles, but because our time at the site was limited there may have been more such structures that we did not identify or are further away from the main site.

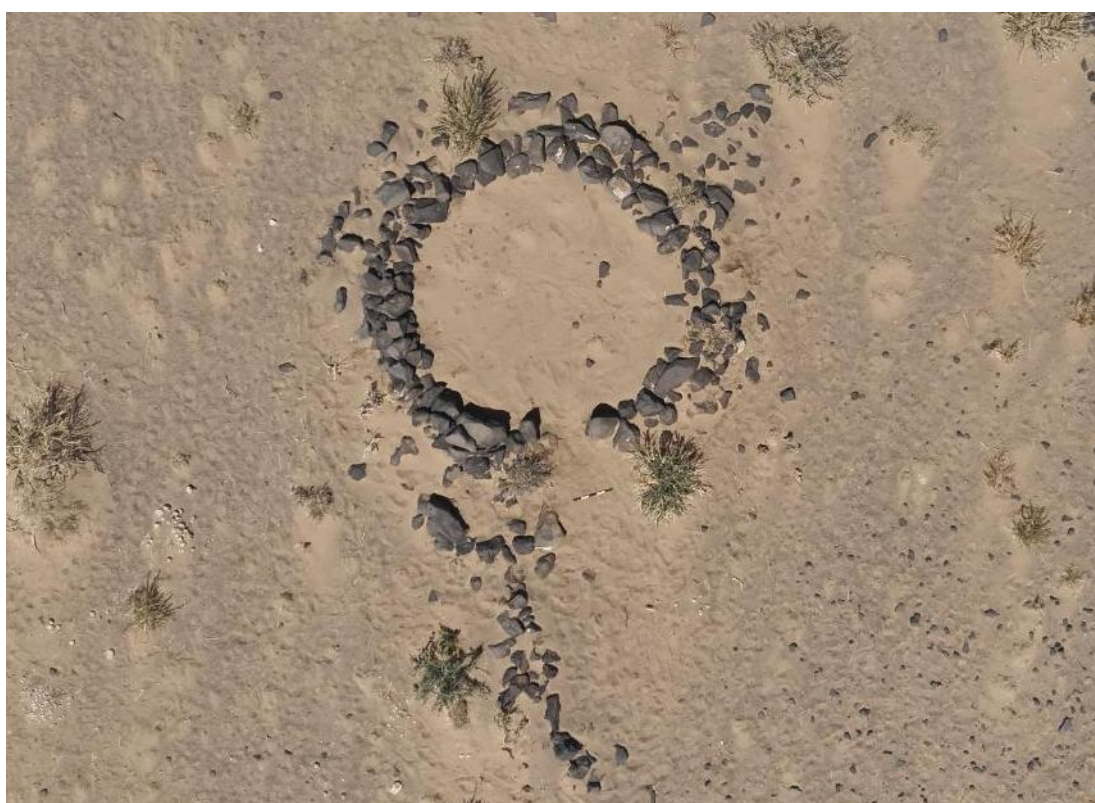
Fig. 45: Drone photos of circular stone structures
